DEPARTMENT OF TRANSPORTATION

Quality Assurance and Source Inspection

Contract #: 04-0120F4Cty: SF/ALA Rte: 80 PM: 13.2/13.9File #: 99.28**WELDING INSPECTION REPORT****Resident Engineer:**Siegenthaler, Peter**Address:** 333 Burma Road**City:** Oakland, CA 94607**Report No:** WIR-019629**Date Inspected:** 27-Jan-2011**Project Name:** SAS Superstructure**OSM Arrival Time:** 700**Prime Contractor:** American Bridge/Fluor Enterprises, a JV**OSM Departure Time:** 1900**Contractor:** Zhenhua Port Machinery Company, Ltd (ZPMC) Chanxing Island **Location:** Shanghai, China**CWI Name:** Mr.SHAU JIAN YUAN**CWI Present:** Yes No**Inspected CWI report:** Yes No N/A**Rod Oven in Use:** Yes No N/A**Electrode to specification:** Yes No N/A**Weld Procedures Followed:** Yes No N/A**Qualified Welders:** Yes No N/A**Verified Joint Fit-up:** Yes No N/A**Approved Drawings:** Yes No N/A**Approved WPS:** Yes No N/A**Delayed / Cancelled:** Yes No N/A**Bridge No:** 34-0006**Component:** OBG Segment**Summary of Items Observed:**

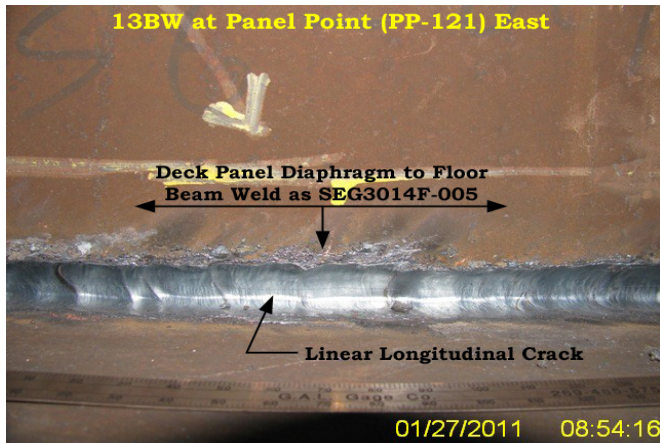
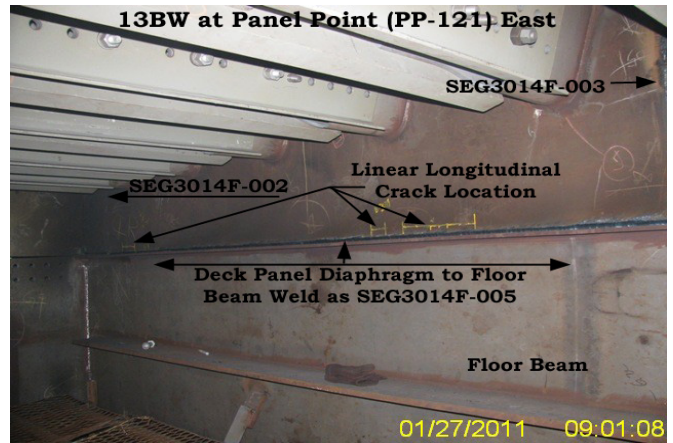
ZPMC personnel performing Air Carbon Arc Gouging (ACAG) for back gouging of Complete Joint Penetration (CJP) welds joining the deck panel diaphragm to floor beam weld joint located on 13BW at Panel Point (PP-121) East side. The weld is designated as SEG3014F-005. After back gouging linear longitudinal crack found by Visual Testing & measured 450mm, 75mm & 150mm in length on three location of gouged area. The information passed over the ABF QA Mr. SHEN JIAN for to perform the magnetic particle testing after grind the full length of weld & repair the weld. Further weld detail mention in attached picture.
